## First Baptist Church: A Testament to Sustainable Roofing

Holly Hill, South Carolina

# PROJECT SPOTLIGHT

## MONOSEAL ROOFING SYSTEM

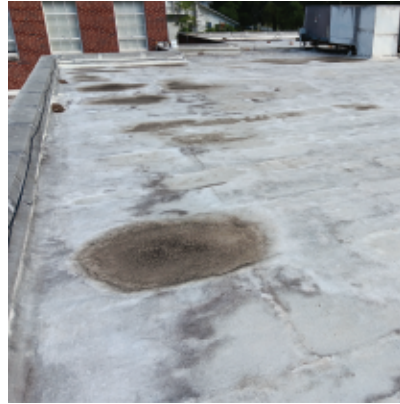
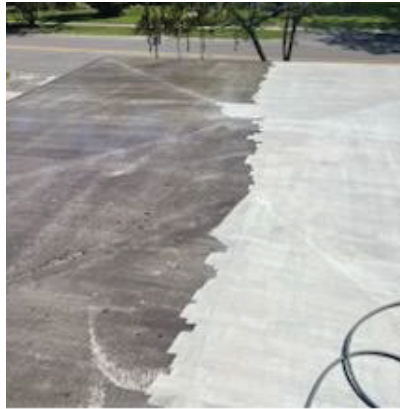
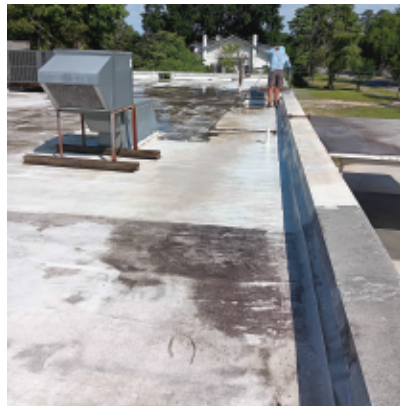
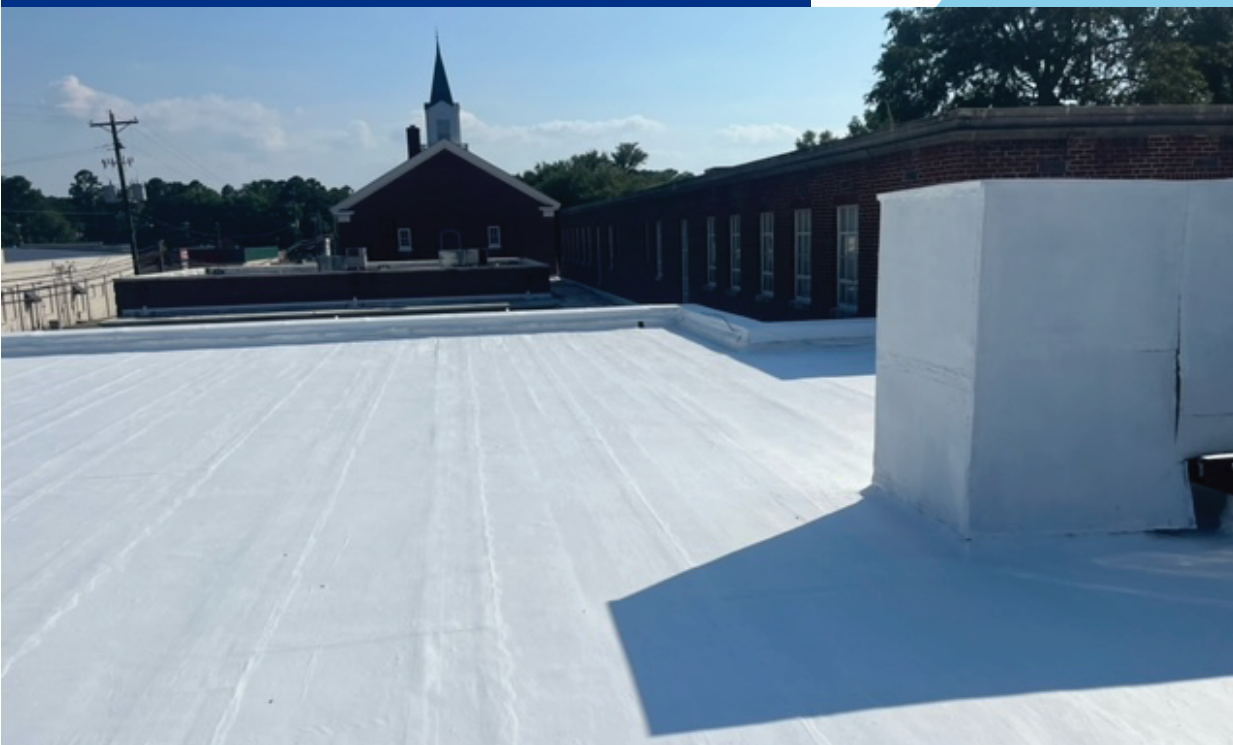
- In 2013, the church had an aging, 20+ year-old modified bitumen (MODBIT) roof.
- Rather than opting for a traditional replacement, they chose a liquid-applied reinforced acrylic coating system.
- This solution extended the roof's life by over a decade.
- It avoided the high costs and environmental impact of a full roof replacement.
- The roof remained watertight, flexible, and functional for 12+ years.
- In 2025, only a surface-level refresh was required—no tear-off necessary.
- The ability to recoat instead of replace exemplifies AguaSeal's sustainable roofing approach.

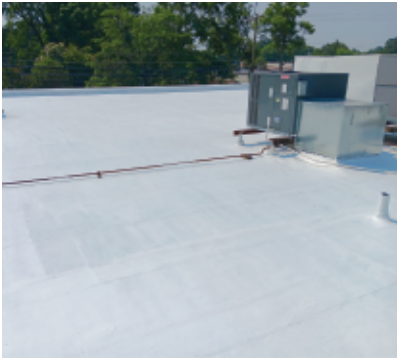
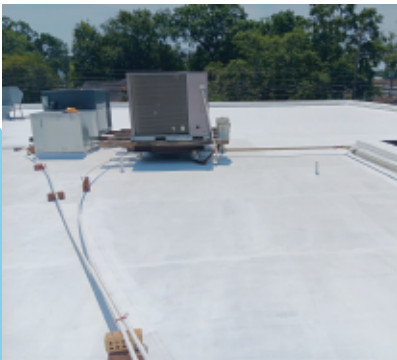
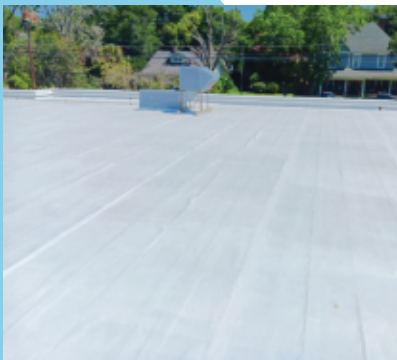
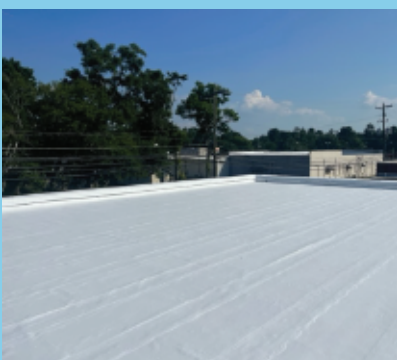
Granulated Modified Bitumen Roof System estimated to be 20+ years old.

- Selected for its sustainability and compatibility with future recoating.
- Applied over the entire roof surface, including parapets and curbs.
- Installation cost: \$550 per square.
- System components:
  - Two base coats with embedded non-woven polyester fabric
  - Two white top coats
  - Total minimum thickness: 40 mils
- Designed with a 10-year renewable warranty.
- Naturally weathered over 12 years, with minimal erosion: only 0.5–0.75 mils/year.
- By 2025, the roof remained:
  - Watertight
  - Soft and flexible
  - Structurally sound with only surface-level discoloration (from pine sap and pollen)

- Roof underwent standard inspection and pressure washing in 2025.
- Cleaning revealed excellent preservation of the underlying roofing system.
- Key findings:
  - Original base coats and embedded fabric were fully intact
  - Finish coats had effectively protected the system over 12 years
- No replacement materials required.
- Maintenance included:
  - Surface cleaning
  - Application of two fresh coats of MonoTop White at 0.75 gallons per square
- Resulting system improvements:
  - Remaining thickness increased from 30–34 mils to 44–48 mils
  - Final thickness exceeded that of the original 2013 installation

Liquid-Applied Reinforced Acrylic System – Installed in 2013

Routine Maintenance – Demonstrating Long-Term System Integrity
